Joint Network Secretariat Urgent Procedure Task Force “Extreme effects of thermal overload in special cases of freight operation

**Final report –**

**Part 3: Detailed information on the work of the  
JNS task force**

02.February 2022

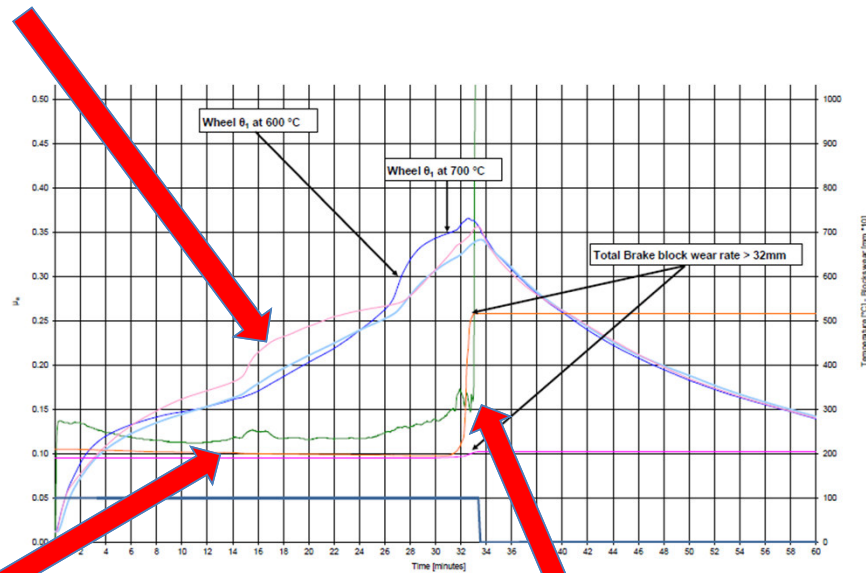
test program A6 of UIC leaflet 541-4 – example test result LL-block - type A

At temperature of approximately 700°C, significant increasing wear (self destroying) and in parallel decreasing temperature of the wheel

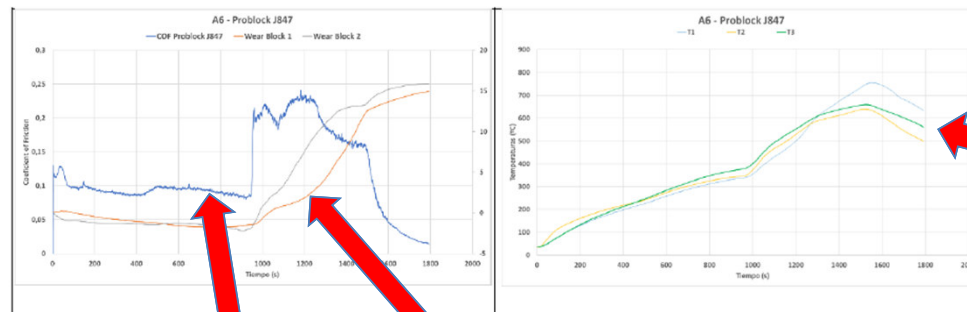
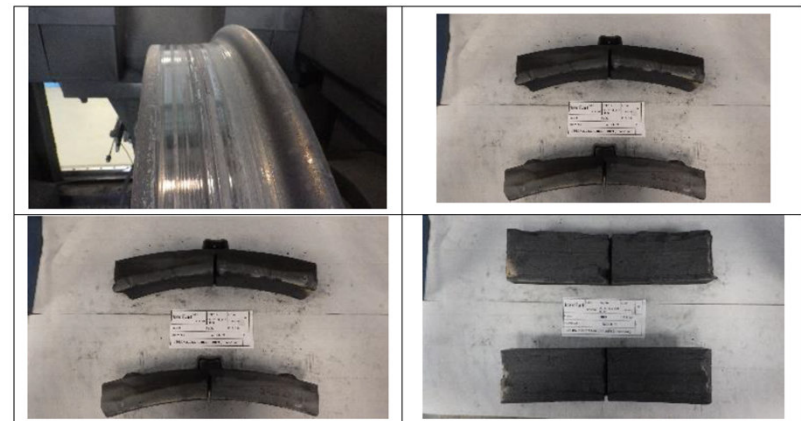
Locked brake testing  
test program A6 of UIC leaflet 541-4 – example test result LL-block - type B

At temperature of appr 400°C, significant increasing wear up to max value of 16 mm, at that time the average wheel temperature is approximately 700°C

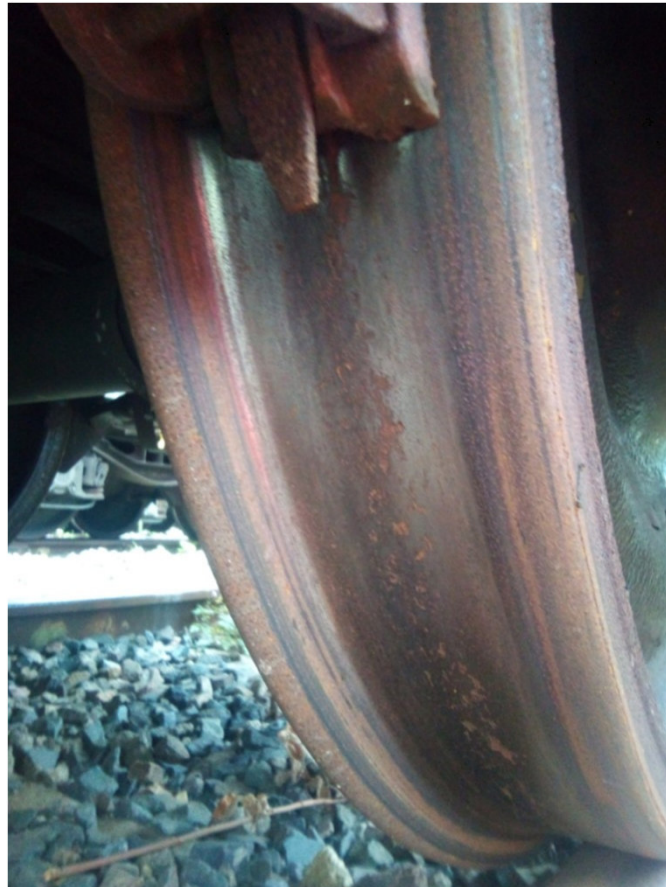
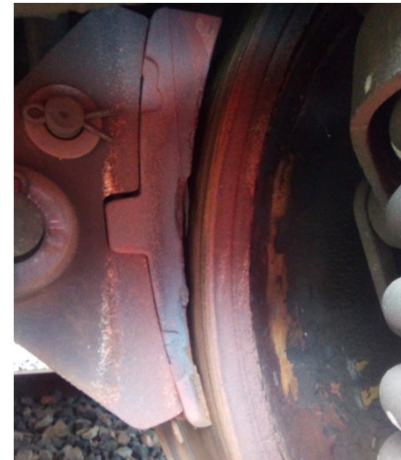
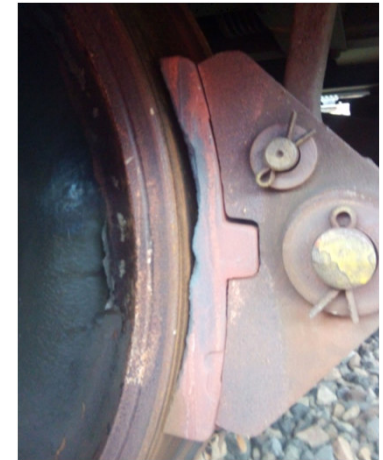
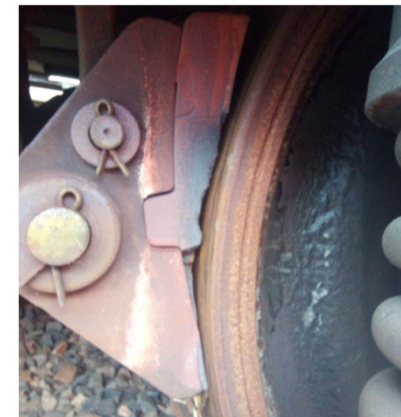
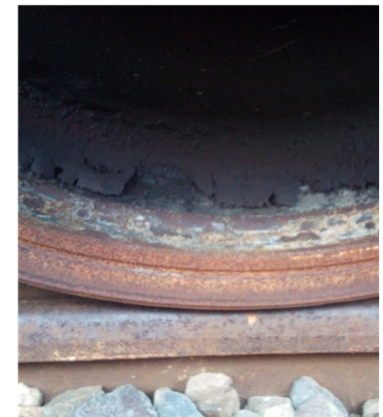
EXAMPLE: CAST-IRON #1

- Significant thermal overload
- Impact on the blocks
- Impact on the wheels (web and treads)

This incident has generated  
**sparkling + smoke + fire along  
the track**

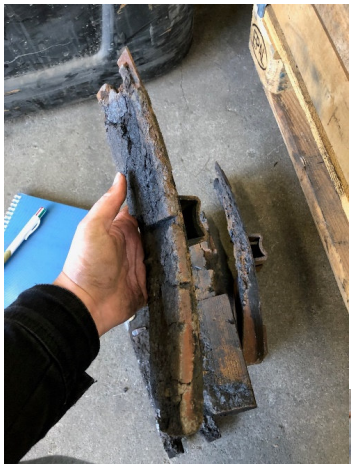
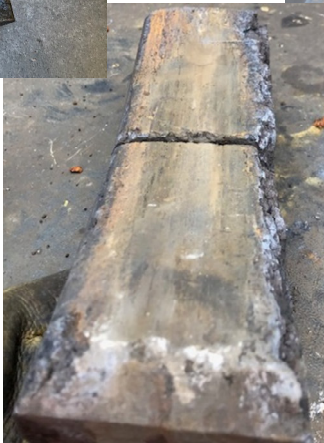
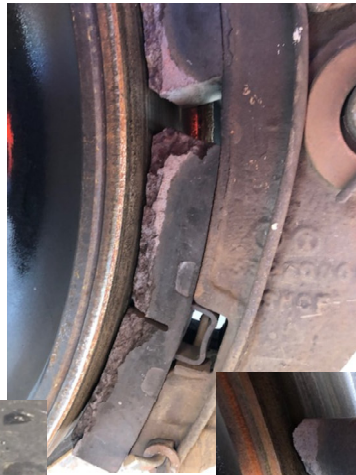
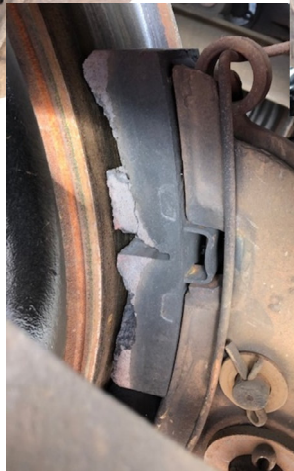
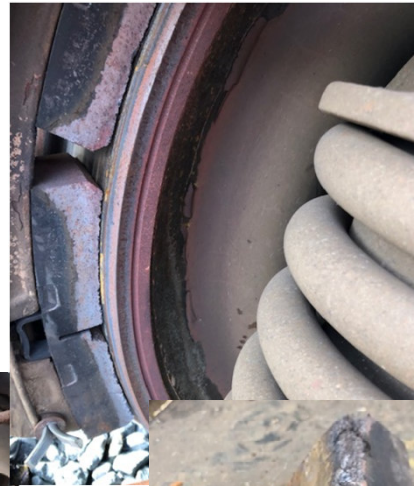
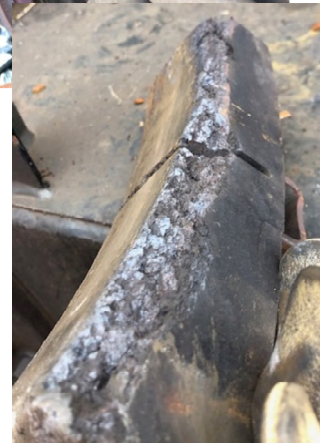
### PARTICULAR BEHAVIOR OF IB 116\*

All IB116\*  
after  
unintended  
brake  
applications

### Singular behavior noticed

- Behavior was analyzed
- To be kept in mind that the block has to destroy itself during the fixed brake
- Seems unusual (does not “only” wear)
- Damages on the brake block and signs of thermal overload on the wheel

**Needs to be further investigated  
(normal procedure)**

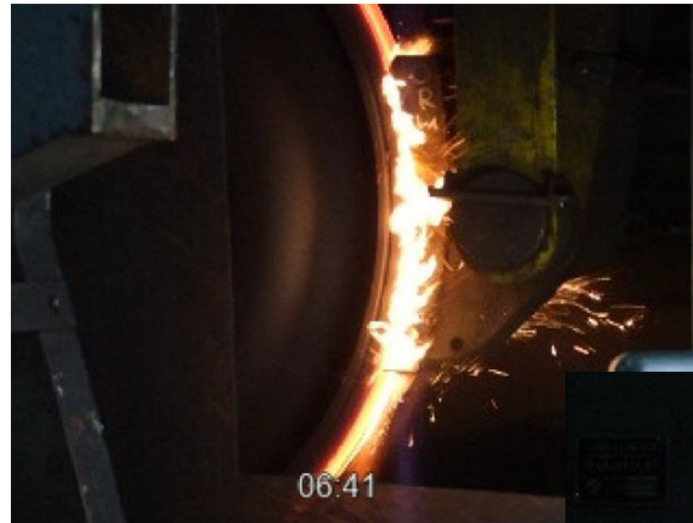
LL-Block  
at max. fire state

Two heat affected Zones

- One is created by the brake blocks through radiant heat and open flames (yellow)
- Second due to the heating of the wheel tread (red)

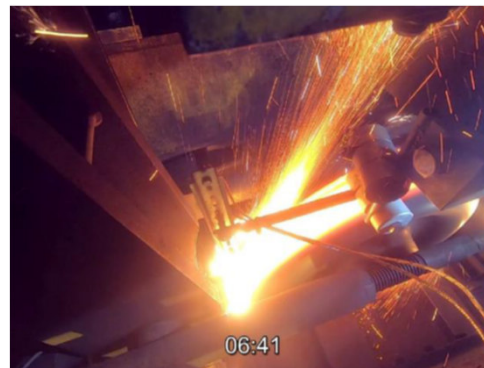
LL-Block

- The sparking of the rear brake direction of travel represents the main source for sparks. The sparks produced can occur at a distance of  $< 1$  m from the point of spark formation in direct contact with the brake block.
- Possible burning materials may act as an ignition initiator. It is estimated that, in addition, the ignition effect of the sparks decreases considerably.

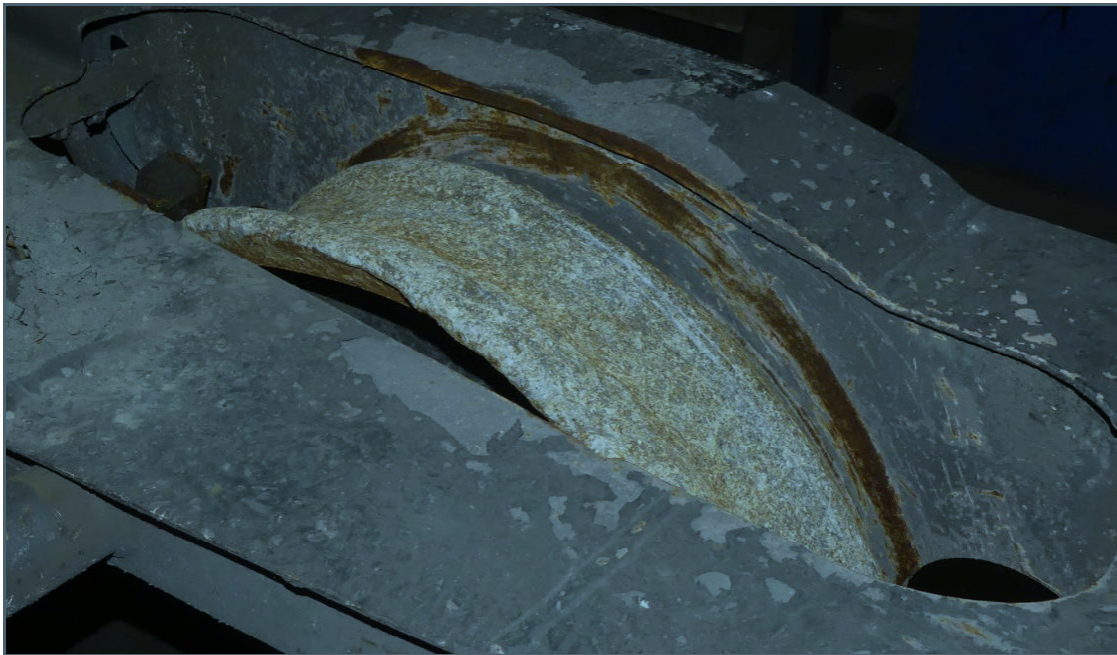
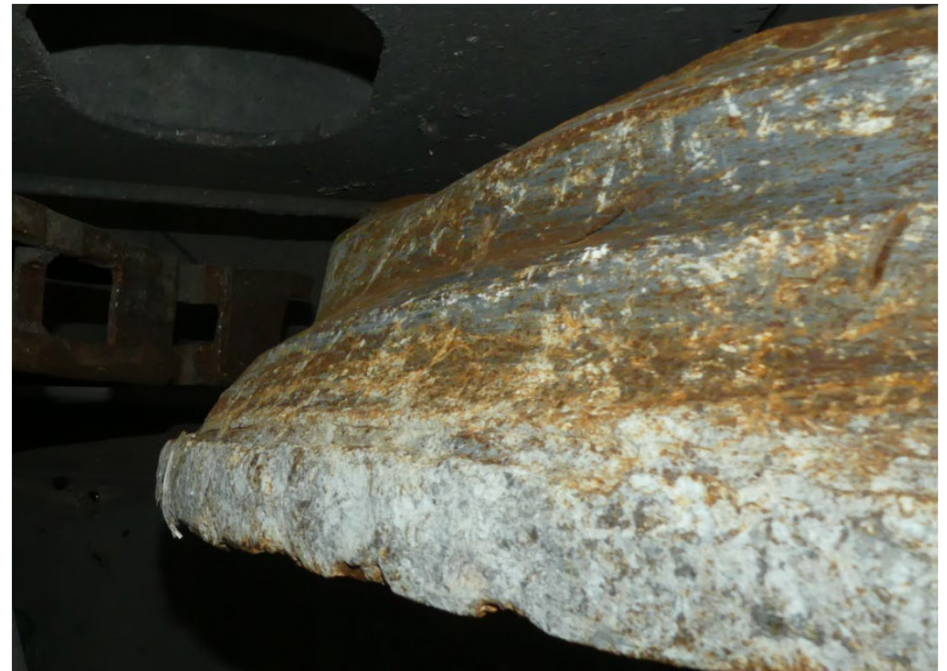
CASE 7 “2020-05-17\_66583\_PM PANICALE\_DB”

- Keeper : DB Cargo Germany
- Derailment case.
- Yes, to categorize as “2” as the wheel is highly damaged.

- ➔ Interaction Wheel / brake block needs to understand what exactly leads to such a picture of damage.
- ➔ By the elements collected on the event, there is no evidence that the case is directly related to IB116\* issue and could occur with different brake blocks.

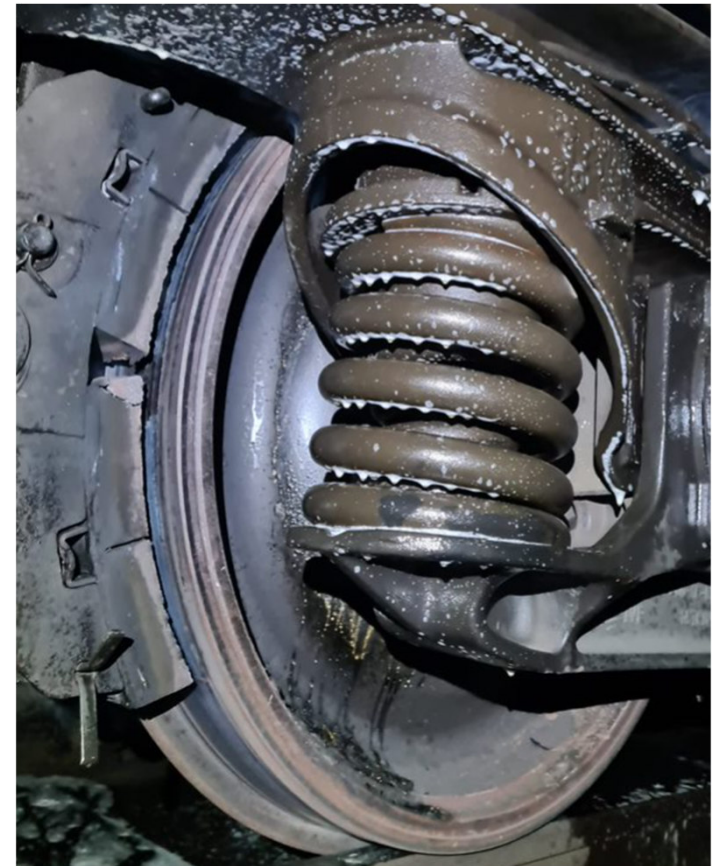
CASE 10 “2020-09-25\_47227\_GEMONA\_MIR”

- Keeper : Rail Cargo Austria
- Fire case.
- Update after Meeting 11th January, categorization 1

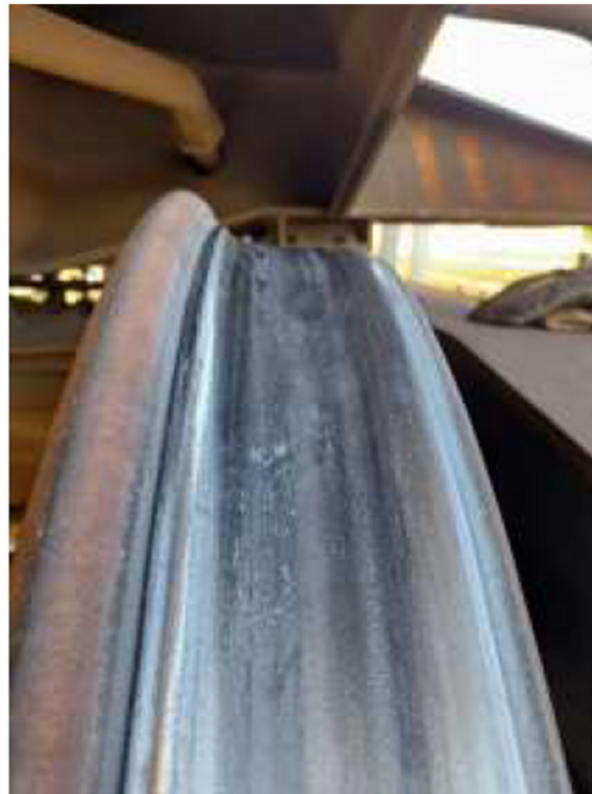
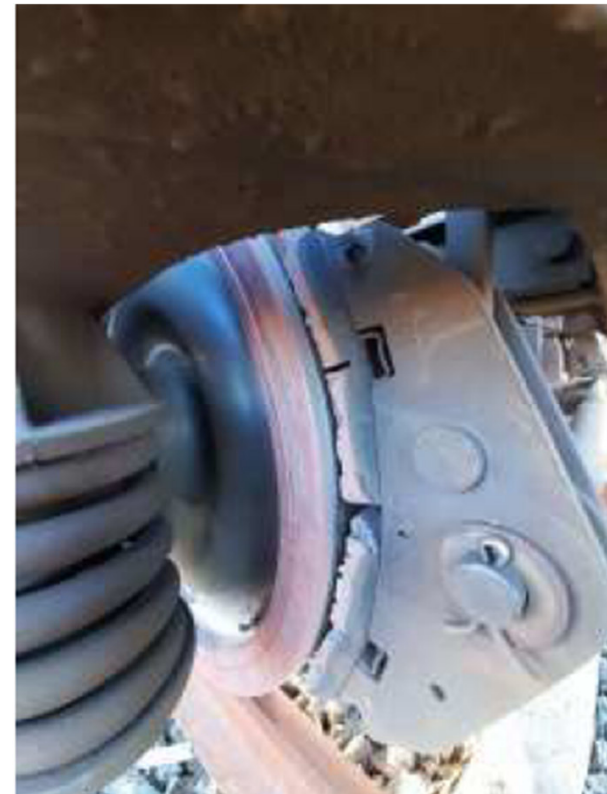
CASE 17 “2021-04-02\_56440\_SARZANA\_MIR”

- Keeper : VTG Rail Europe
- wheel damage is categorized as “2” after evaluation based on the photos in part 2 about the extraordinary deformations
- Extraordinary wheel tread deformation near the flange

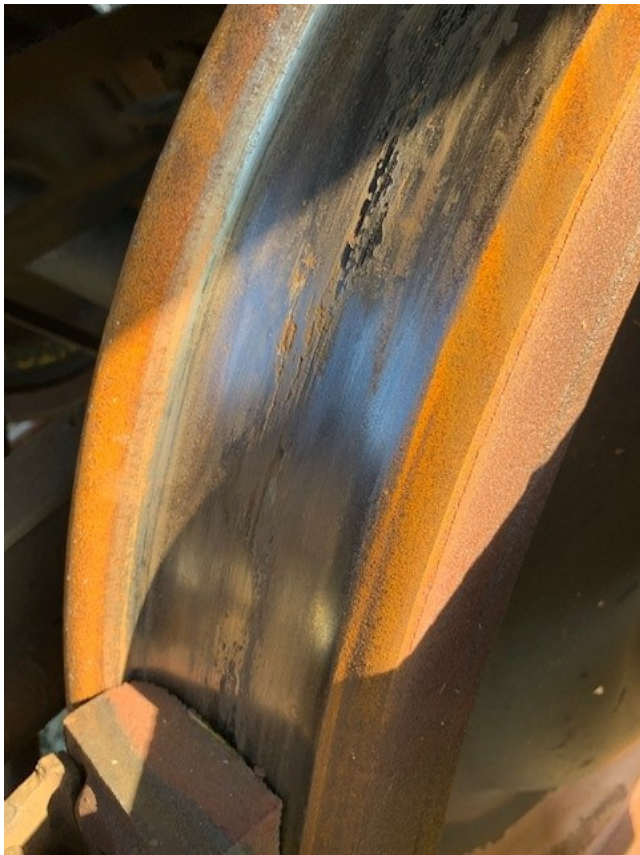
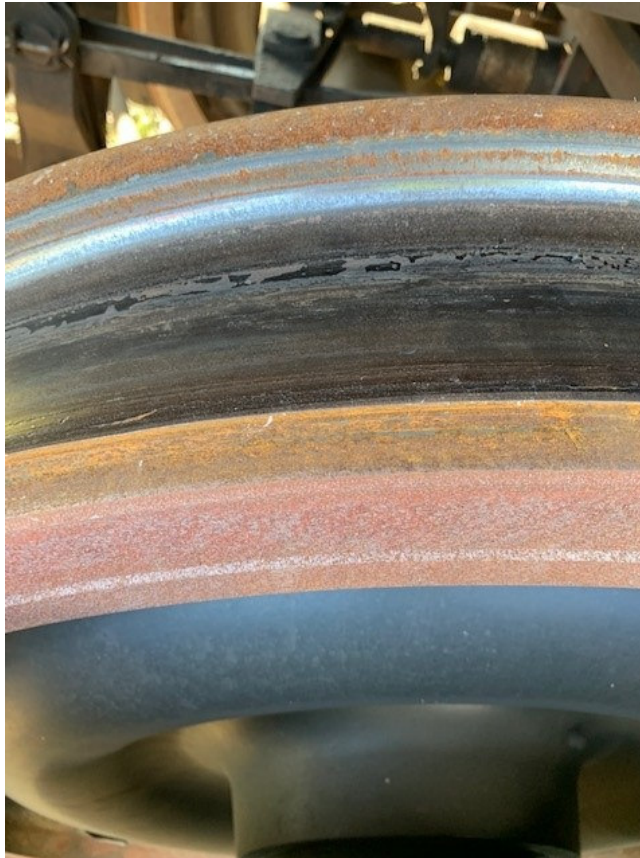
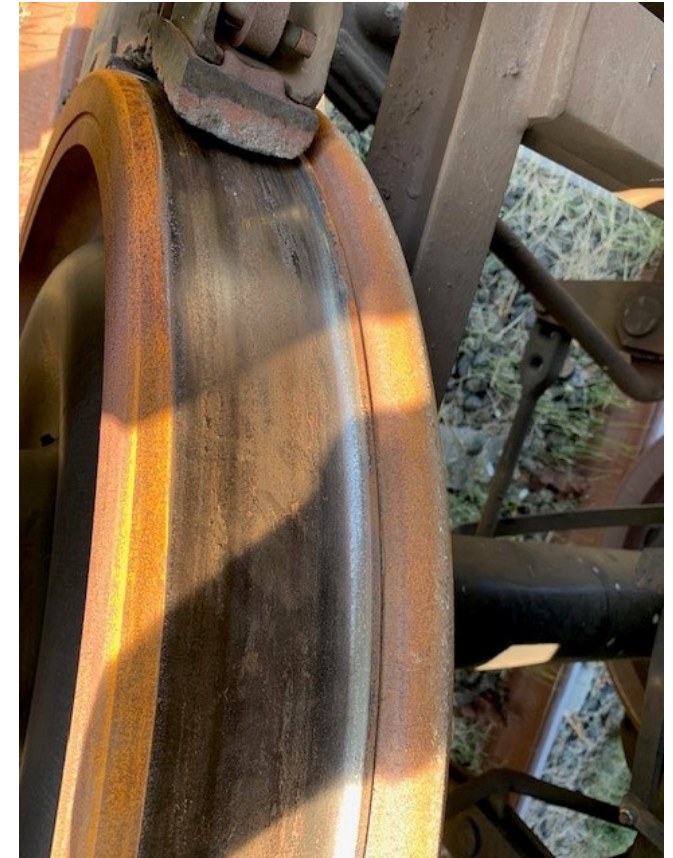
CASE 17 “2021-04-02\_56440\_SARZANA\_MIR”

Wheelset without extraordinary wheel tread deformation

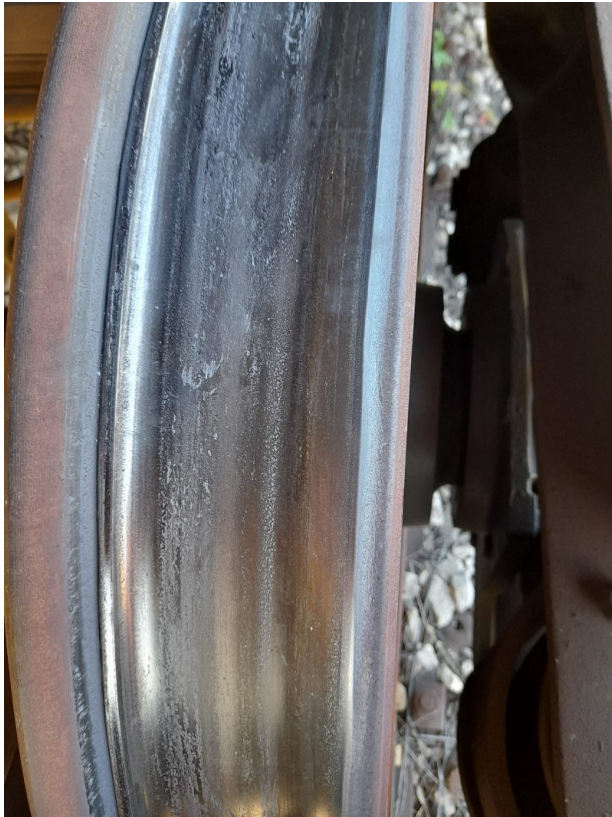
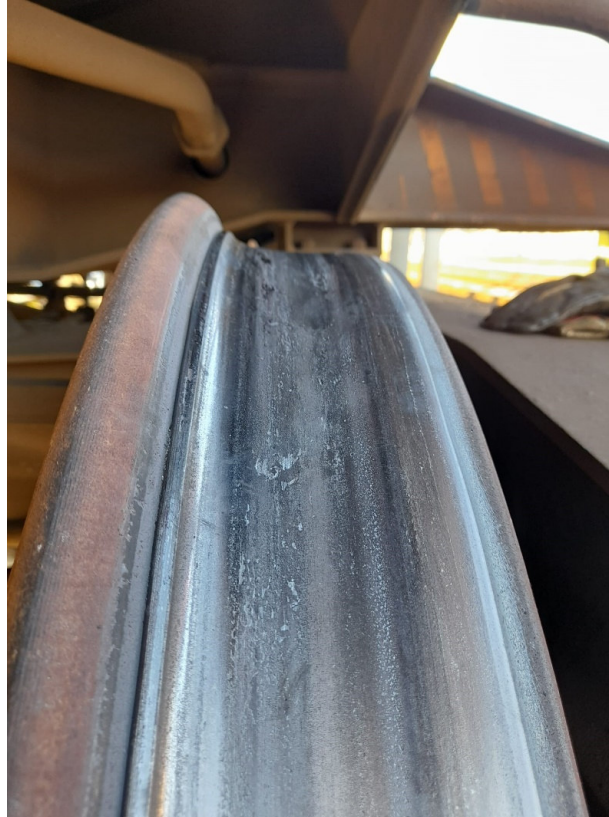
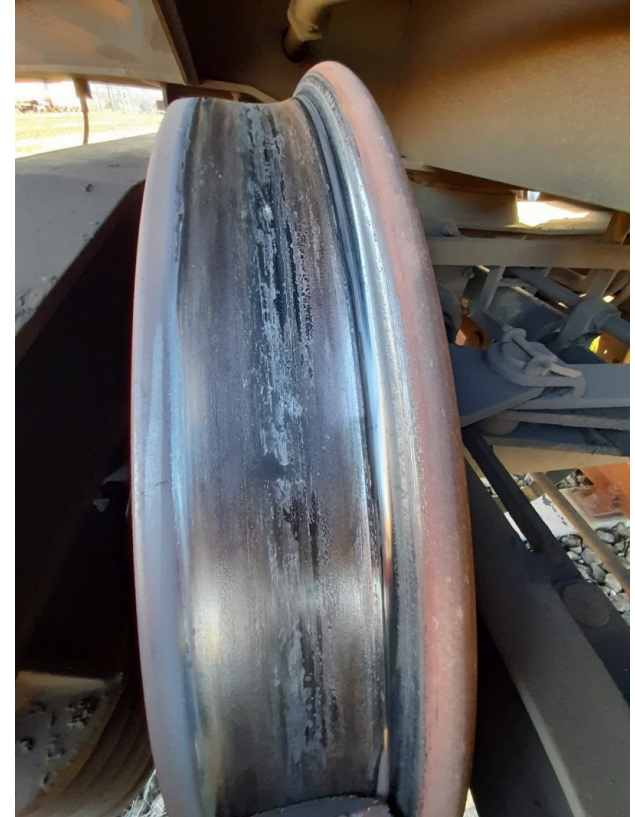
CASE 17 “2021-04-02\_56440\_SARZANA\_MIR”

Wheelset with extraordinary wheel tread deformation

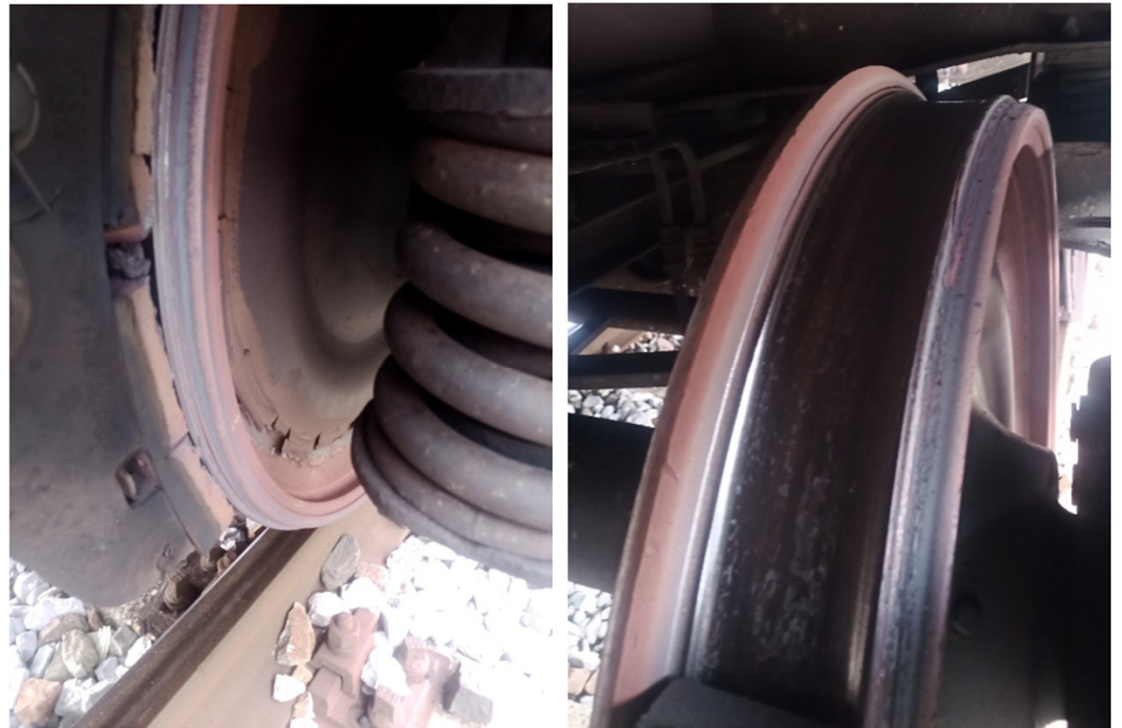
CASE 23 “2021-06-07\_44235\_CARNIA\_MIR

- Keeper : Železničná spoločnosť Cargo Slovakia, a.s.
- Yes, wheel damage is to be categorized as “2” after evaluation based on the photos in part 2 about the extraordinary deformations
- Extraordinary wheel tread deformation near the flange and on the outer side of the tread

| data analyzed | Evidence collected | Evaluation |
|---|---|---|
| Brake system operation | Brake test report available | Abnormalities detected. (A-Chamber, leakage) |

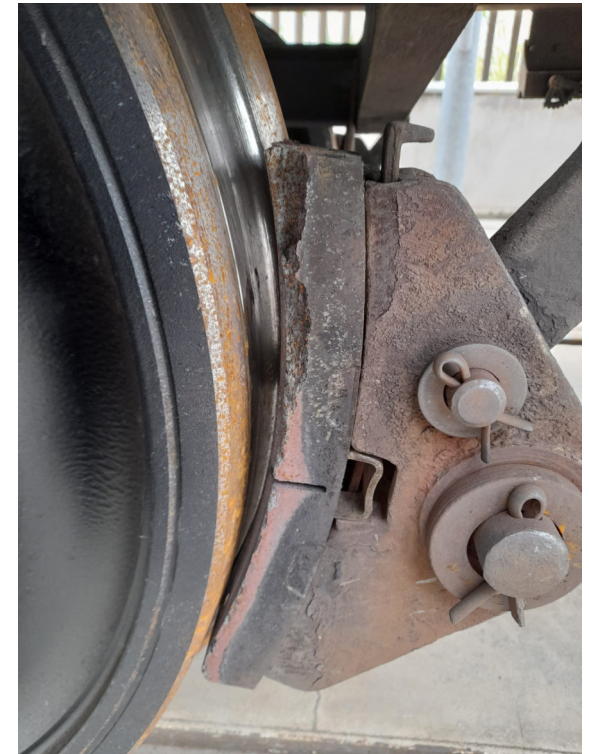
CASE 28 “2021-0729\_63842\_SPRESIANO\_CAPTRAIN”

- Keeper :Petrociterne (SA)
- Fire case.
- From data available, the wagon was able to run at lower speed without replacement of the wheelsets.
- After meeting 11th January, Categorized “1”

- Picture with changed wheelsets after incident
- Picture with signs of thermal overload on the brake blocks,, see short-term risk control measure 2.1.5
