Joint Network Secretariat Urgent Procedure Task Force “Extreme effects of thermal overload in special cases of freight operation

**Final report –**

**Part 3: Detailed information on the work of the  
JNS task force**

02.February 2022

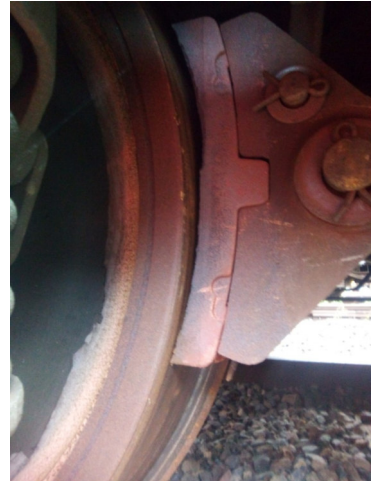
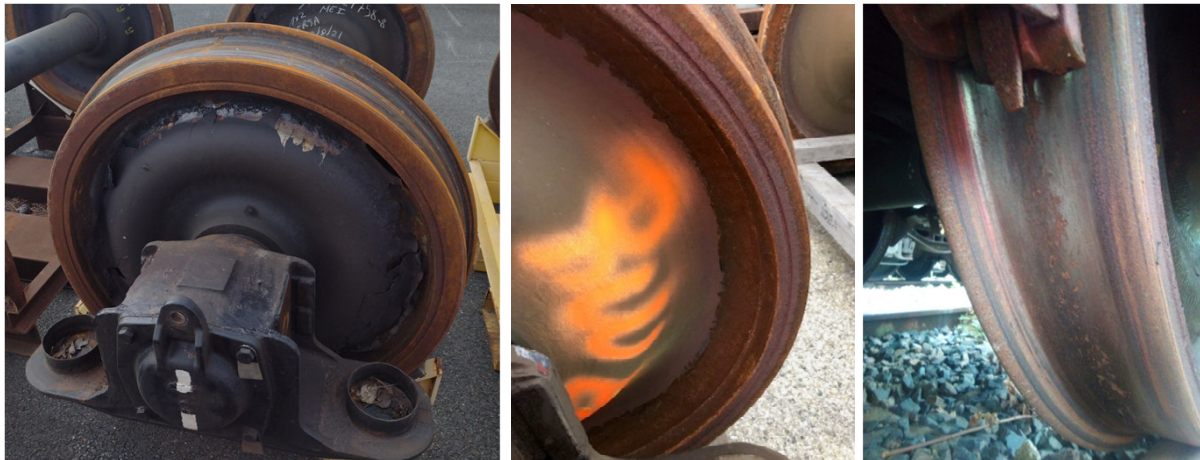
- In Operation, locked brakes are to be avoided since they generate wagon immobilization, wheelsets replacements, multiple costs, etc.
- Locked brakes situations are not normal BUT are NOT exceptional either.
- Locked brakes can be caused by malfunctions to the braking system in particularly by applied handbrake, air leakage on the Brake Pipe, air leakage due to bad air supply filtration, problem of overload of the brake system, problem on the distributor, brake control issues, etc.

### Ordinary fixed brakes

- Have an impact on the blocks and the wheels
- Not safety relevant
- No critical damage of the wheels

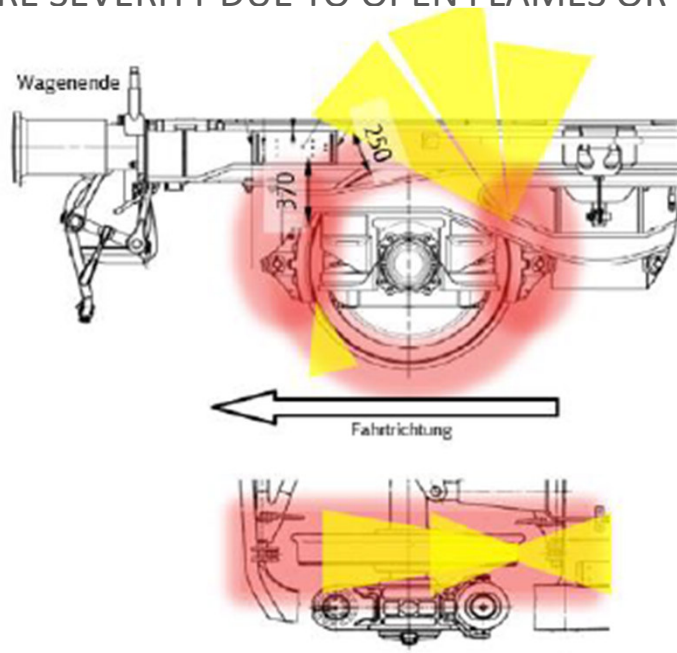
Two heat affected Zones

- One is created by the brake blocks through radiant heat and open flames (yellow)
- Second due to the heating of the wheel tread (red)

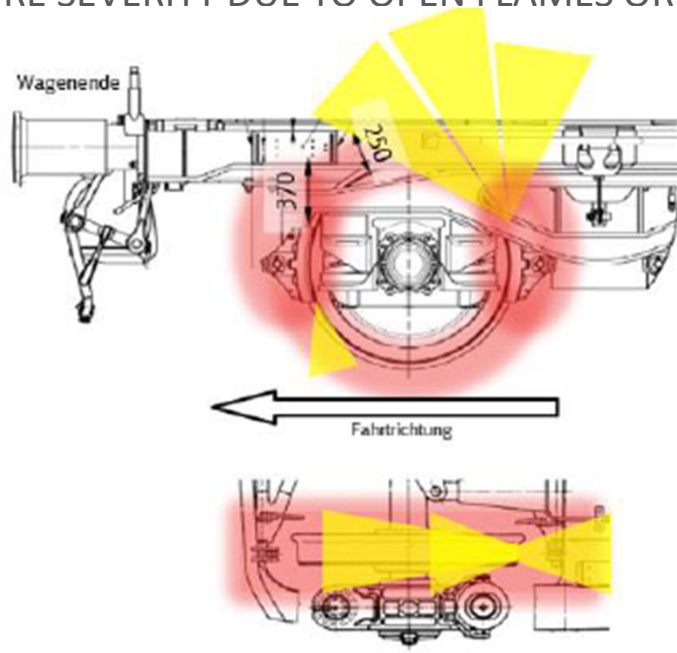
#### Two heat affected Zones

- One is created by the brake blocks through radiant heat and open flames (yellow)
- Second due to the heating of the wheel tread (red)

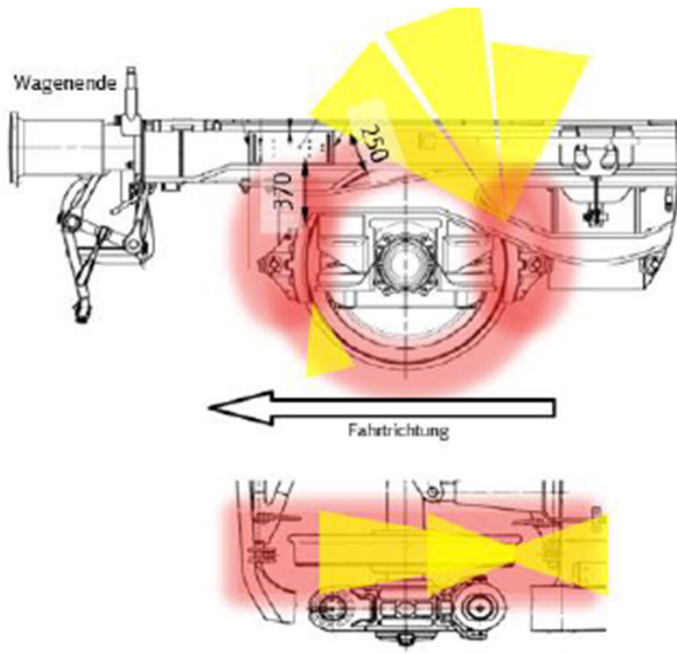
Effects on the cargo when using CBB

- The sparking of the rear brake direction of travel represents the main source for sparks. The sparks produced can occur at a distance of  $< 1$  m from the point of spark formation in direct contact with the brake block.
- Possible burning materials may act as an ignition initiator. It is estimated that, in addition, the ignition effect of the sparks decreases considerably.

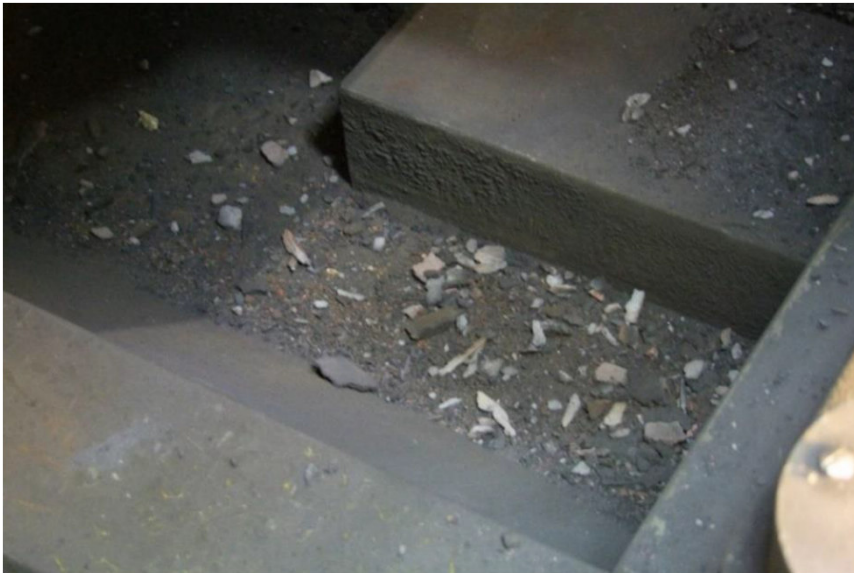
#### Effects

- The largely flaky material spalling from the burning brake blocks was examined. The fragments of the blocks had a maximum volume of 1 cm<sup>3</sup>. The fragments of CBB that were produced during the test were collected by the collection tray under the test stand.
- A spreading of the fragments beyond this was not detected. The ejection distance is therefore limited to the immediate vicinity of the braked wheel.

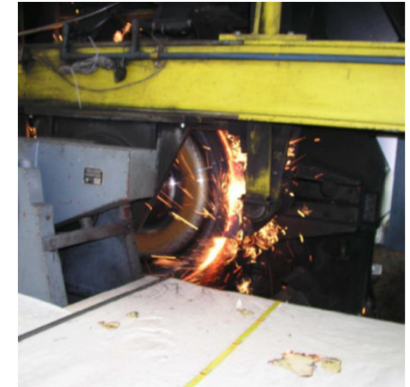
### Conclusions **broken out material**

- Broken out block material of composite brake blocks has a significant ignition potential for slope fires and cargo.
- But comparing the technological and physical properties of CBB and CI material, it becomes clear that the heat capacity of fused beads made of cast iron material is far higher than that of the CBB material.
- **Due to the difference in heat capacity, the ignition potential of broken-out CBB is lower than that of beads from molten cast iron blocks.**

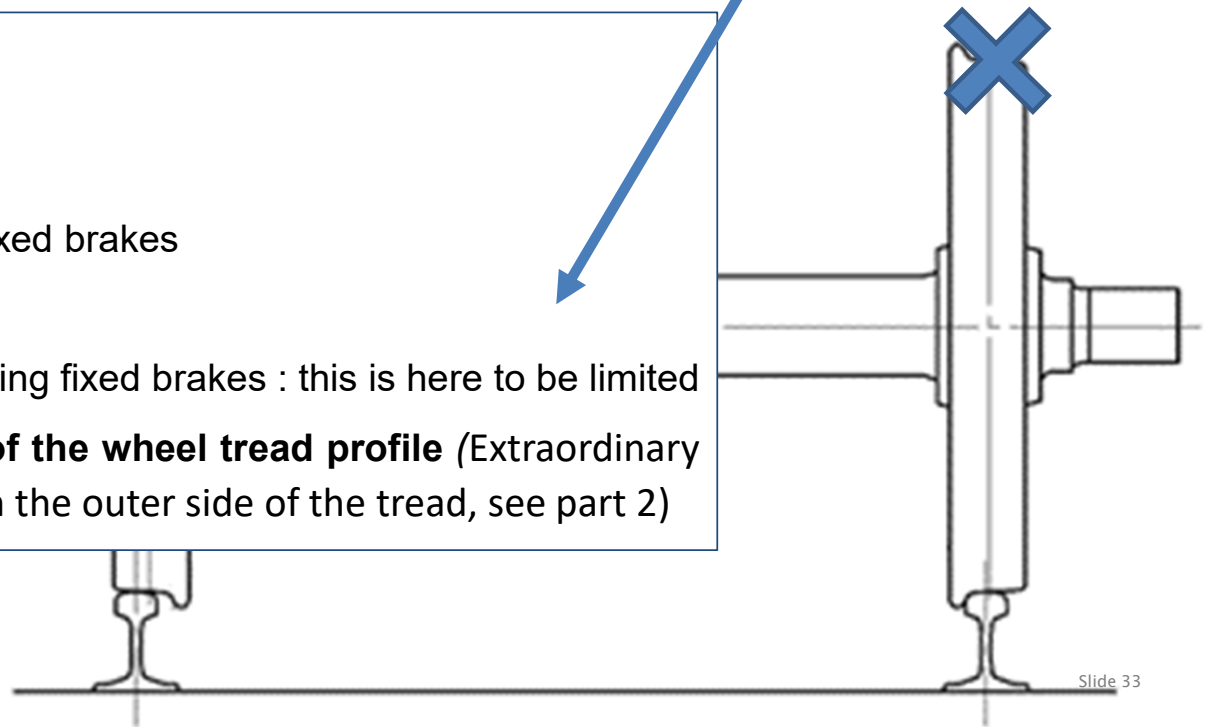
**New scale established to categorize wheel damage after a fixed brake event**

**0** : no damage of the wheel tread

**1** : usual damage of the wheel tread during fixed brakes

**2** : **Unusual damage of the wheel tread** during fixed brakes : this is here to be limited to **damages generating a strong deviation of the wheel tread profile** (Extraordinary wheel tread deformation near the flange or on the outer side of the tread, see part 2)

Pictures and/or  
measurements  
necessary

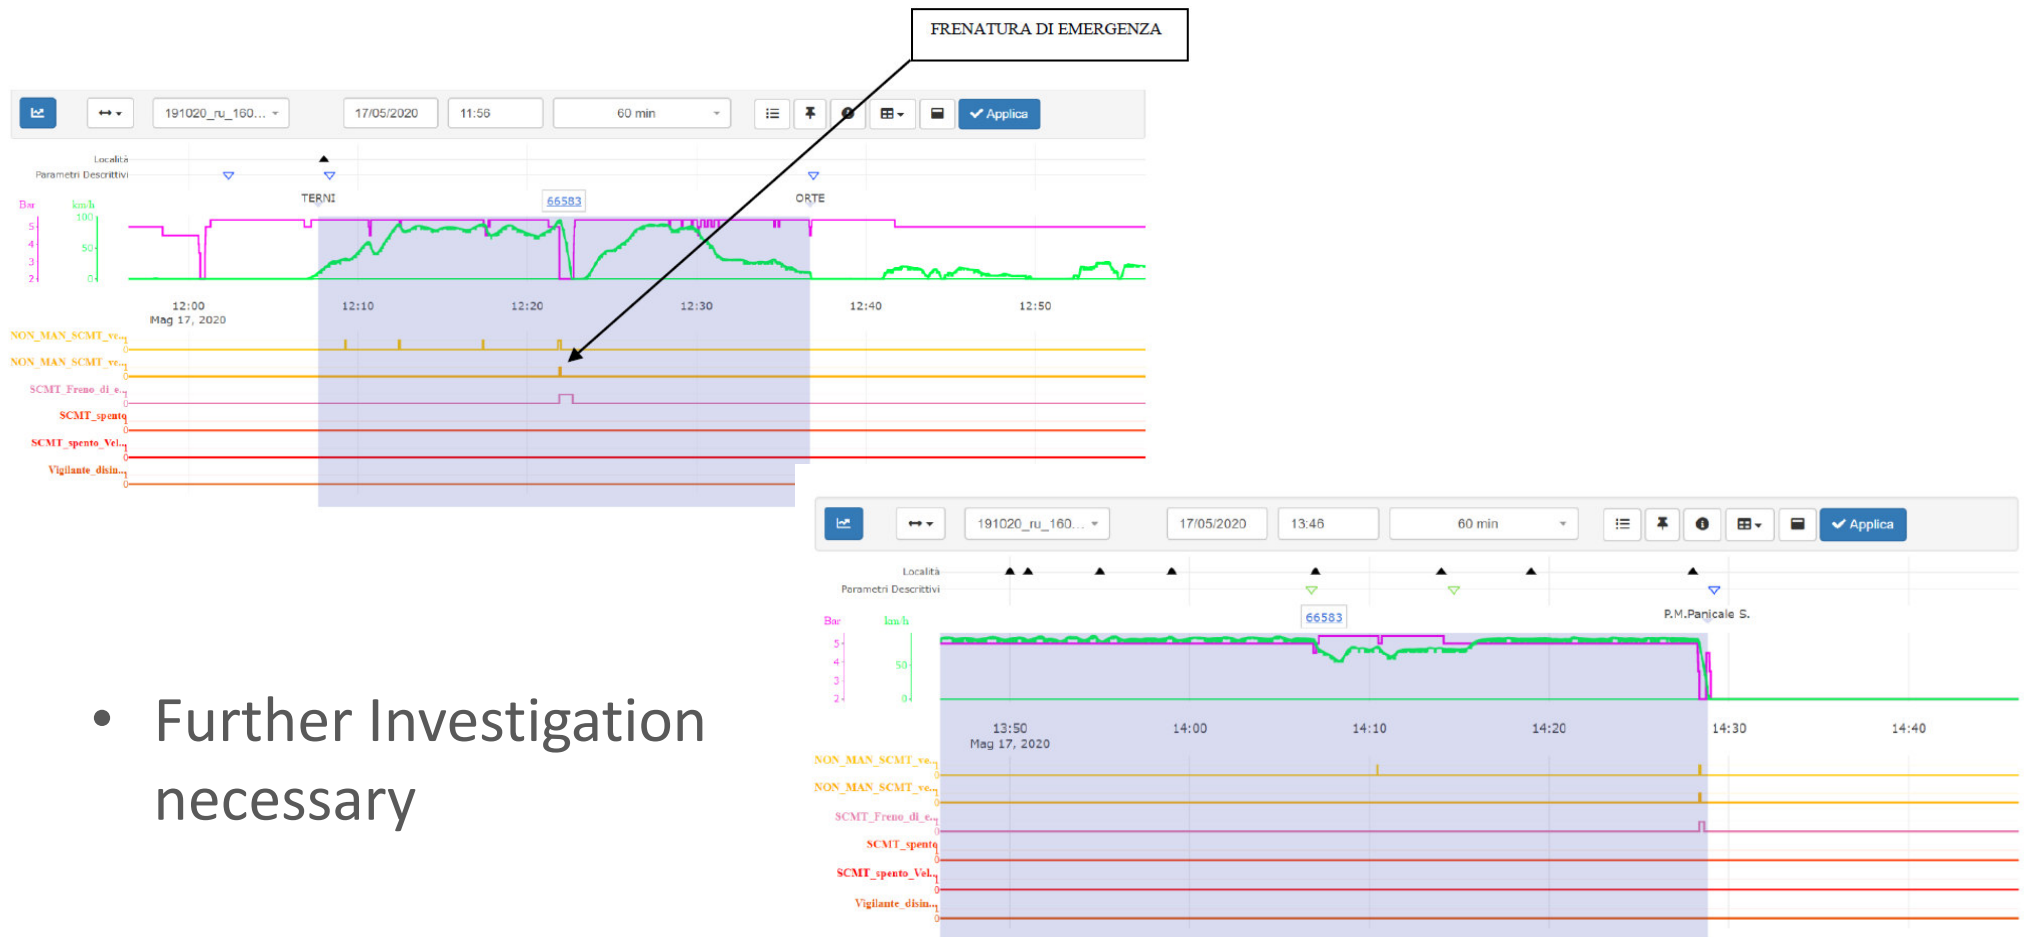
### CASE 7 “2020-05-17\_66583\_PM PANICALE\_DB”

- ➔ Interaction Wheel / brake block needs to understand what exactly leads to such a picture of damage.
- ➔ By the elements collected on the event, there is no evidence that the case is directly related to IB116\* issue and could occur with different brake blocks.
